Case Study

Emergency Collector Ring Insulation Repair Fall 2010

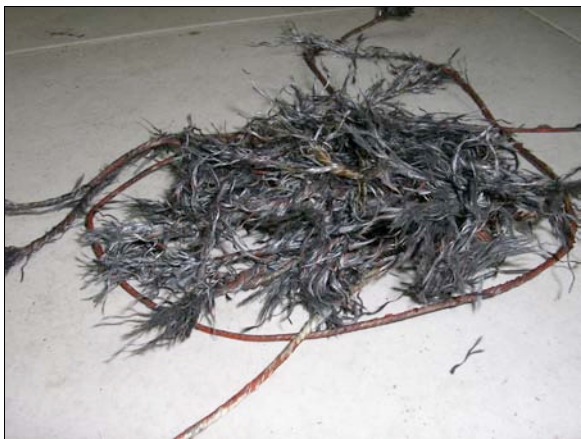
figure 1

An overseas power plant called requesting immediate help for repairing the insulation banding that had come apart while their gas turbine generator was in operation. Brush holders were damaged as banding (see figure 1) came apart and caught on the holders (red arrows in picture below indicate problem area). The problem was compounded by the approach of the customer's peak operating season which would not allow for a lengthy outage.

Cutsforth responded back to customer immediately to inform them we could perform the repair to their generator. Cutsforth coordinated the details of the field service repair with their site personnel, reviewed the plan and material requirements and then expedited customer required safety documentation. The actual repair was completed in a single day allowing the generator to be back up and running the following day minimizing their outage losses. The unit has not had any further issues from this problem since the repair.
