### Case Study: Electromagnetic Interference Monitoring (EMI)

#### **East Coast Generation Facility: Background and Challenges**

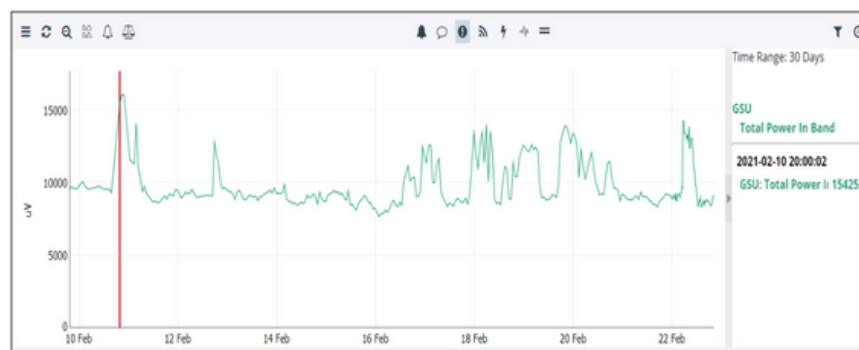
EMI was installed late in the year along the GSU, GCB, and generator. The first weather-related event was detected a few months later during a rain and snowstorm at the GSU. However, the RFCTs at the GCB and generator did not detect similar spikes. The following week, a second event was detected during another snowstorm.

*First weather-related event*

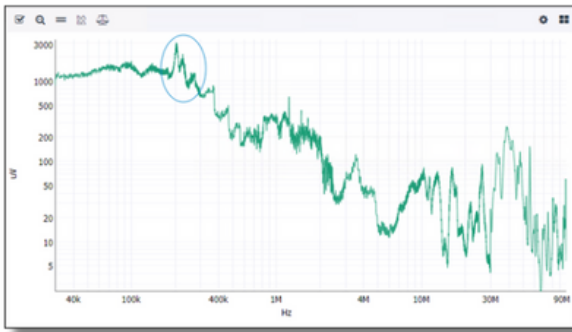
Image 1 shows the EMI Power Spectrum waveform before the snowstorm, while Image 2 shows the Power Spectrum during the event.

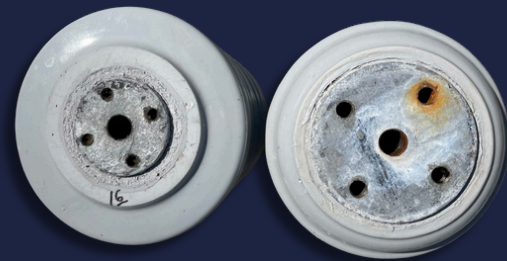
The plant put together a checklist of assets to inspect and clean based on the EMI readings. Team members weren't originally planning on opening the isophase bus during the next outage. However, based upon EMI system findings and corresponding HiPot test results, it was determined that an inspection of connection points at the generator, GCB, and GSU would be warranted. Upon further inspection on the phase with the lowest HiPot results, thirteen insulators were identified with moisture damage.

Thirteen insulators in one of the isophase ducts were damaged by water intrusion, which would have led to a forced outage.

The plant was able to identify problem areas by permanently installing a system that constantly takes readings versus doing periodic readings of EMI levels. Cutsforth's EMI system identified weather-related increased noise levels, which would not have been detected by the ad hoc EMI inspections. Undetected, this would have led to a costly multi-day forced outage.

With the combination of the multiple RFCTs with the Cutsforth EMI system and use of the sniffer, the plant was able to clearly identify locations to inspect during the scheduled outage. The permanently installed Electromagnetic Interference system allowed the plant to quickly and easily determine the corrective action to help reduce EMI levels following the scheduled outage.
