### Case Study: Brush Condition Monitoring (BCM)

### Case Study: Southeast Power Generation Plant

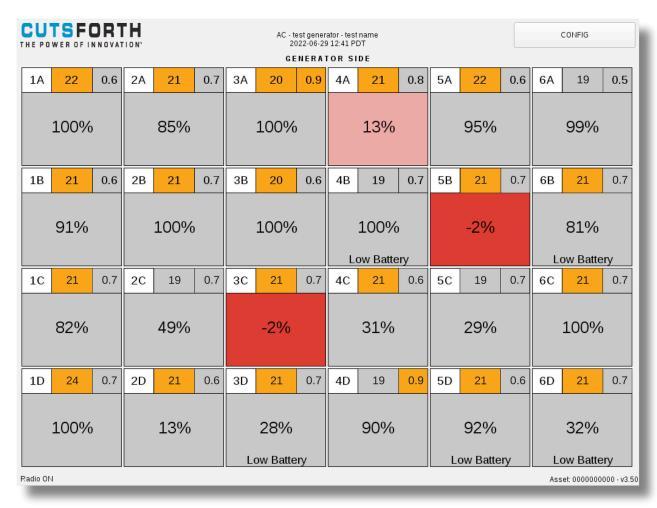
BCM touchscreen user interface

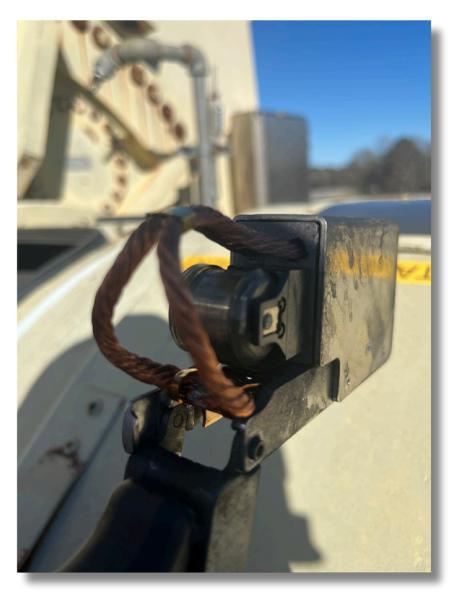
The customer, which had two 7F units and a D11, reported the brush health sensors on their steam turbine were melted. The side of several brush holders showed a splatter pattern indicative of water on collector rings, as seen in the image below.

Brush holder showing water splatter pattern

Water intrusion was determined to be the likely cause. Water on the collector rings washed away lubricating carbon film on the ring surface, thus lessening the quality of electrical connection between some brushes and the ring surface. The decreased current flow through these brushes resulted in lower temperature readings, and the increased friction due to lack of lubricating film resulted in higher vibrations. Other brushes not affected by the water contamination reported higher temperatures due to increased current flow (selective action).

The customer inspected the unit's exciter and discovered significant signs of water inside the housing. Plant personnel investigated gaskets on all openings of the exciter to find the root cause. Using Brush Condition Monitoring, the plant was able to identify and determine the issue before a major failure occurred.

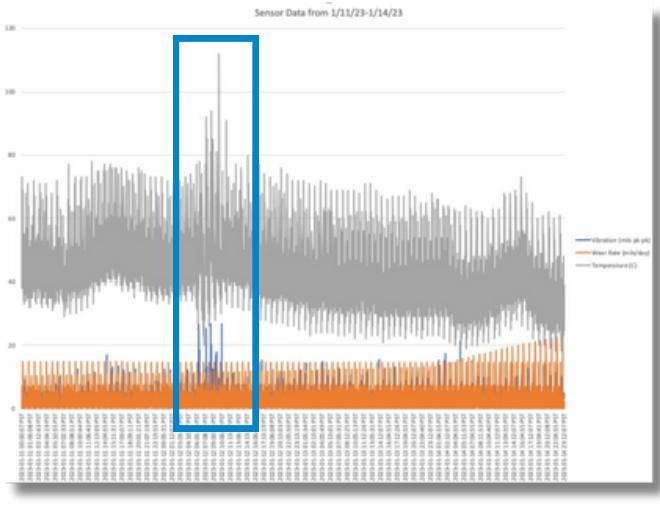
Screenshot showing time frame of spikes in data

The plant sent Cutsforth historical data logs from their BCM system. The data showed a short time frame with extremely high temperatures on some brushes, and extremely low temperatures on others. There were also corresponding elevated vibration readings across the brush rigging. This was determined to be the most likely point at which the melting of the sensors occurred. Thunderstorms were reported in the area during this time frame.

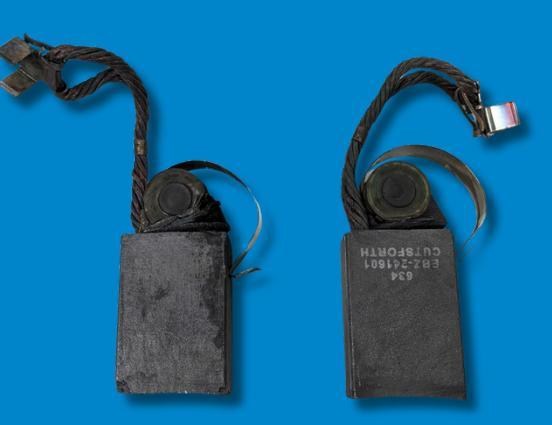
Upon inspection of the damaged brushes and sensors, it was observed that the brush springs were permanently deformed, and the plastic spacers (made from high-temperature plastic) on the back of the brushes were also melted. This indicated temperatures in excess of 700°F.

Melted sensors on the brushes

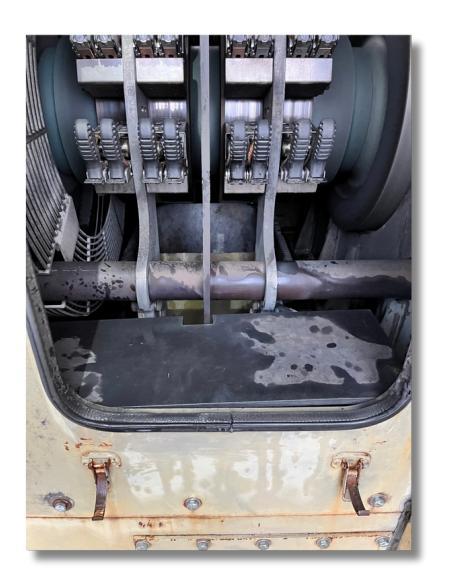
Water intrusion was found to be the cause
